Boulder Creek Building Program Plan

COMMUNITY COLLEGE OF DENVER

16 JUNE 2016

Detailed Conditions Assessment - Exterior

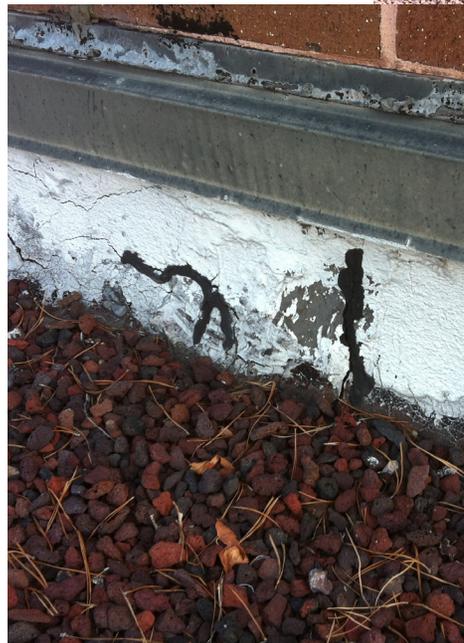
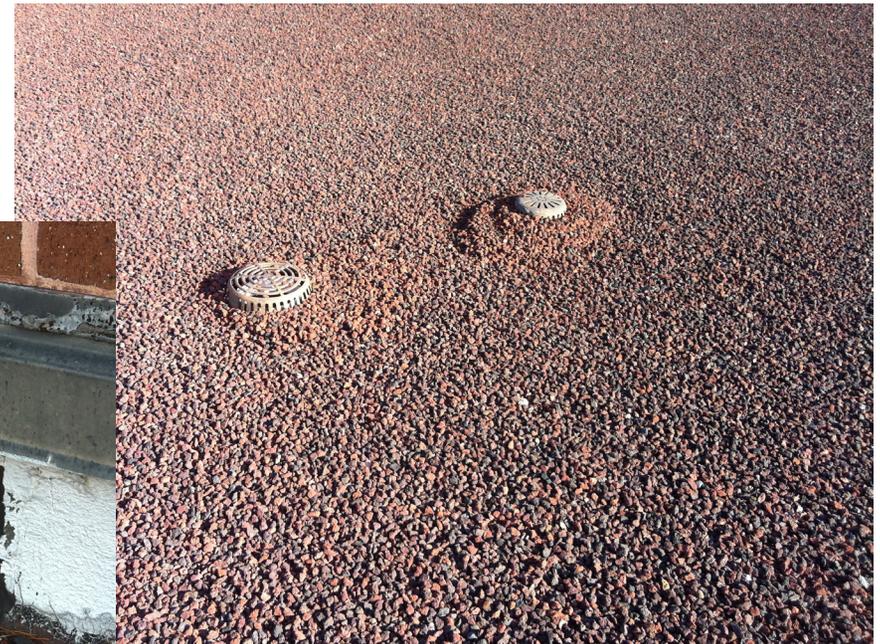
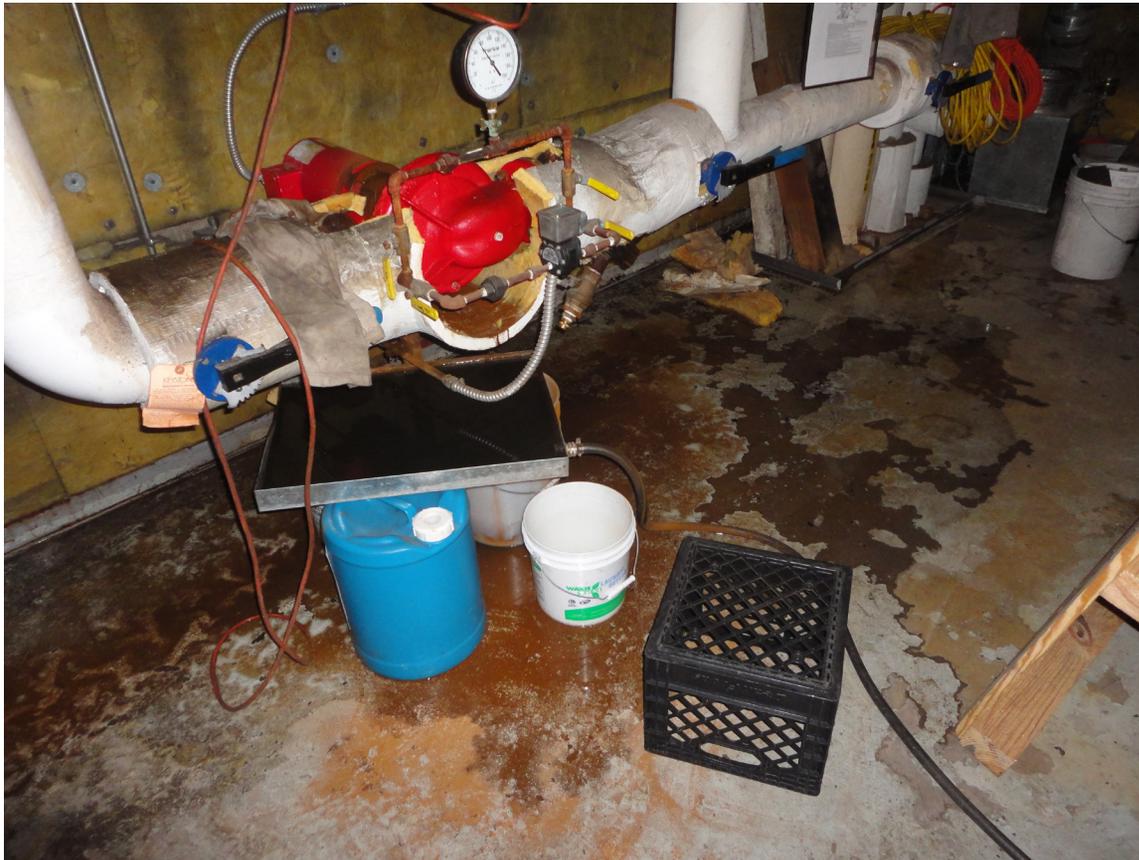
Roof:

The existing built-up roof appears to be original to the building, and is therefore approximately 40 years old. There have been recurrent minor roof leaks. The original perimeter flashing is cracking and has been patched in several locations. The metal counterflashing riveted seams are separating in several locations. The sealant between the through-wall reglet and the counterflashing is peeling out. The light-weight stone aggregate is easily displaced by stormwater and has been scoured away in spots, and has washed up against the roof drains, completely covering some of them. Some of the roof drain strainers are broken, allowing larger debris through to the drain leader piping. The paint on the majority of the sheet metal hoods and ductwork is peeling to a significant extent; the sheet metal is galvanized and does not appear to be significantly rusted yet. The brick on the back side of the parapet is cracked and spalling in places, but this does not appear to be due to efflorescence. The metal parapet cap appears to be in good condition.

Recommendations – Replace roofing and flashing with single ply membrane. Cover with new heavier aggregate matching the existing color. Repair metal counterflashing. Replace damaged roof drain strainers. Paint sheet metal ducts and hoods. Repair or replace cracked brick.

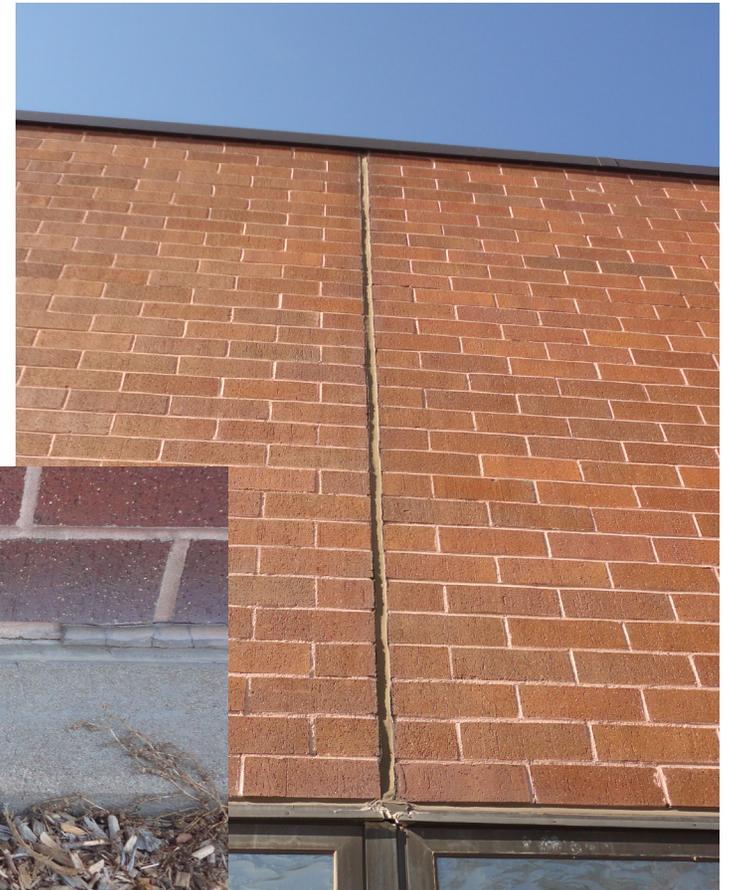
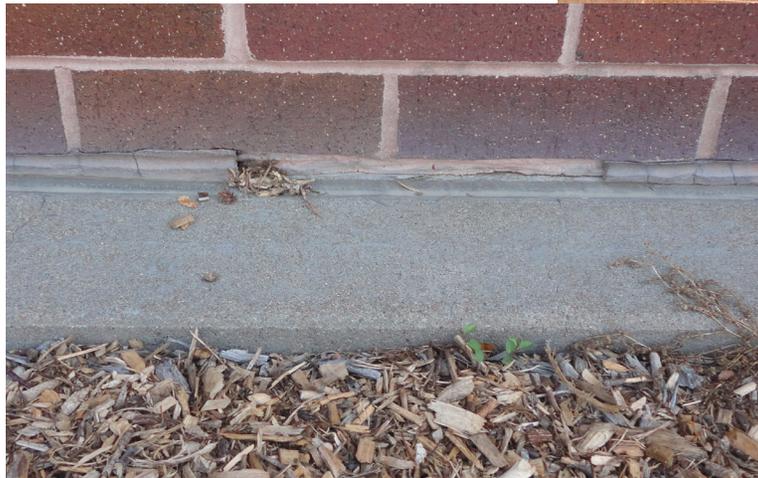
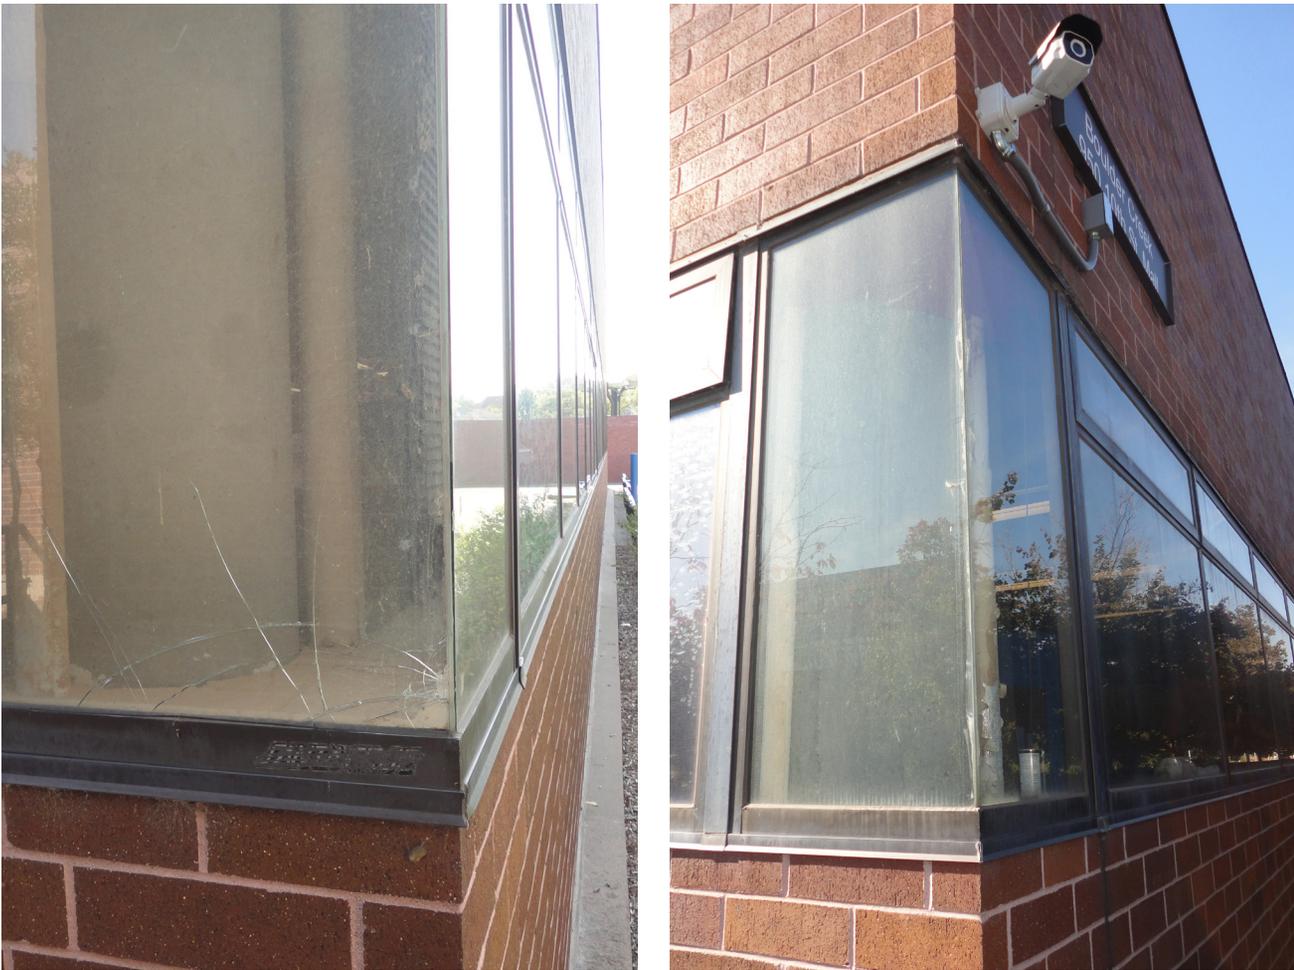
Walls:

The exterior walls appear to be solid brick masonry, without a cavity. Aside from a few areas of minor face shell cracking, the brick and mortar joints appear to be in generally good condition. In several locations the grout between the lowest brick course and the concrete grade beam is spalling and should be tuckpointed. The sealant at the masonry control joints is in good condition. The sealant at the building expansion joint on the 10th Street facade has separated from the brick.

Recommendations – Repair or replace cracked and broken bricks. Tuckpoint bed joint at base of wall. Remove and replace sealant at building expansion joint on 10th Street façade.

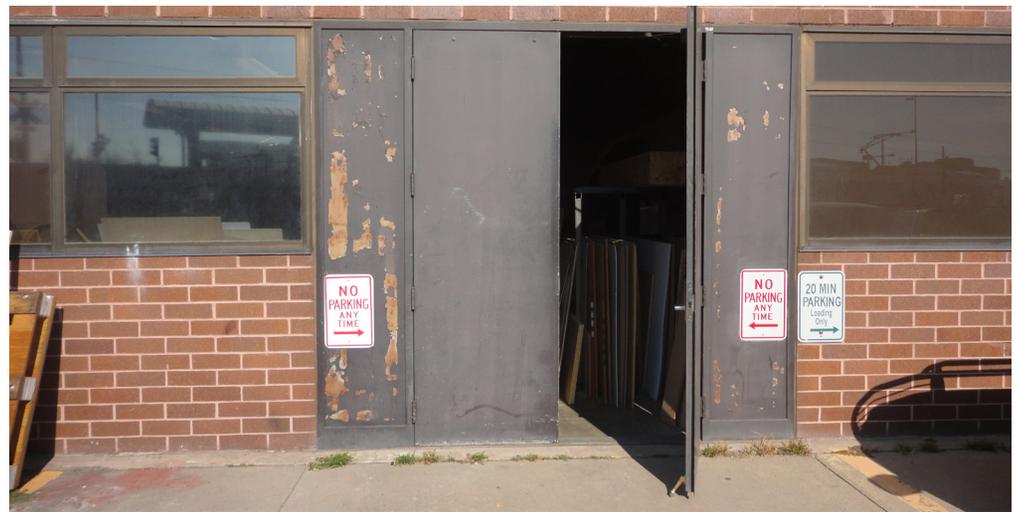
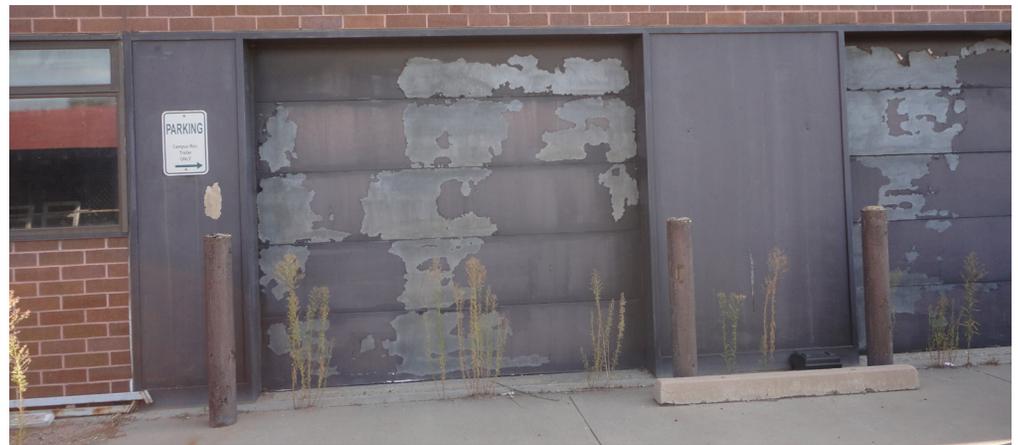
Storefront and Doors:

Storefronts are steel, probably without a thermal break, and with non-insulated glazing. Some rust is visible on the storefront frames. Exterior doors are hollow metal. Except for one door on the southeast side, all doors appear to be original. The paint on the doors is chalky and faded, and peeling in places. Some doors appear to have been repainted, but the color is not an exact match to that on the majority of the doors. Most of the door seals and bottom sweeps are damaged and should be replaced. Door hinges are rusted. The hollow metal sidelight panels on the service court sides are badly rusted due to peeled paint. The paint on the abandoned overhead doors is badly peeled.

Recommendations – Replace storefront with thermally-broken aluminum system with high-performance glazing to match new windows. Replace exterior doors and sidelights. Remove abandoned overhead doors and infill openings to match adjacent construction.

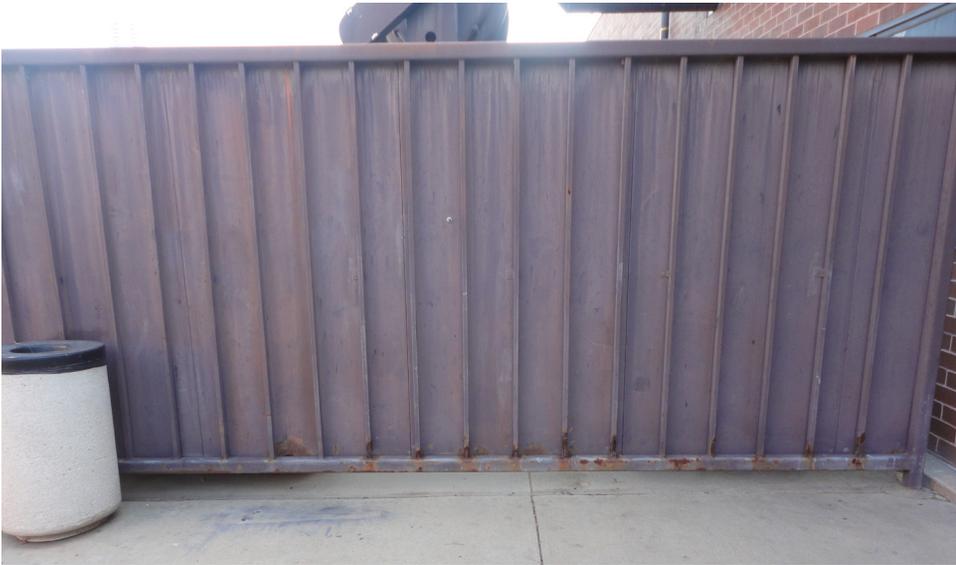
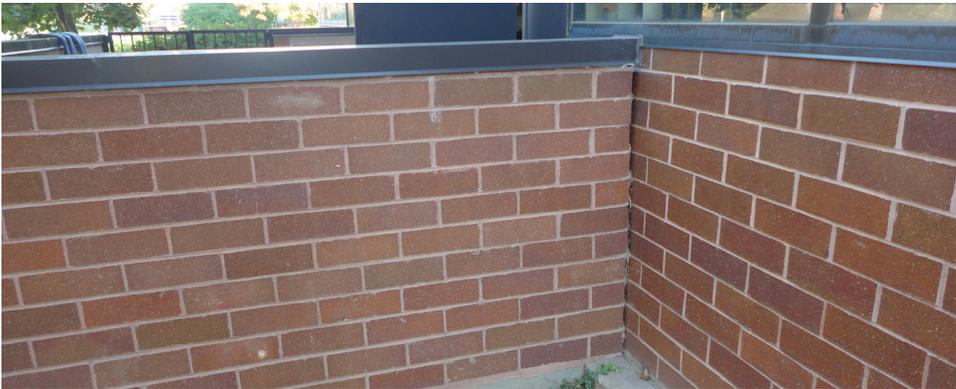
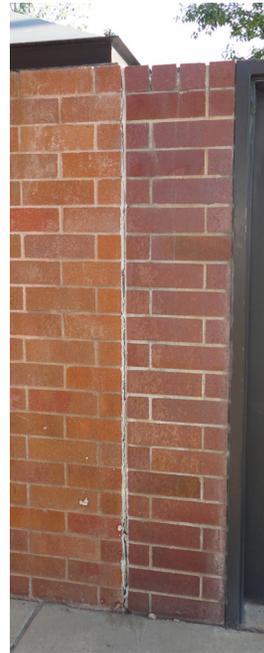
Equipment Enclosures and Retaining Wall:

The steel equipment screen on the northwest side has significant areas of rust (see phot at left). The masonry equipment enclosure on the northeast side appears to have been constructed at a later date, as the brick does not match the adjacent utility building (see photo at left). The sealant joint between this masonry enclosure and the adjacent building has failed, as have the mortar joints in the brick parapet cap. The brick at the drainage scuppers on the cooling tower enclosure has been stained by runoff, and the metal scuppers are damaged.

The brick retaining wall around the service yard has several areas of cracking. Several joints appear to have been tuckpointed in a non-workmanlike manner. Several mortar joints in the brick cap are in need of repointing. The sealant in the control joints has pulled away from the brick.

Recommendations – Replace steel equipment screen with new galvanized and painted screen. Remove and replace sealant at joint between brick mechanical enclosures and at control joints. Tuckpoint brick parapets. Grind out and tuckpoint sloppy bed joints at service yard screen wall. Repair or replace cracked and damaged brick. Clean soiled and stained brick at scupper. Repair or replace scupper.

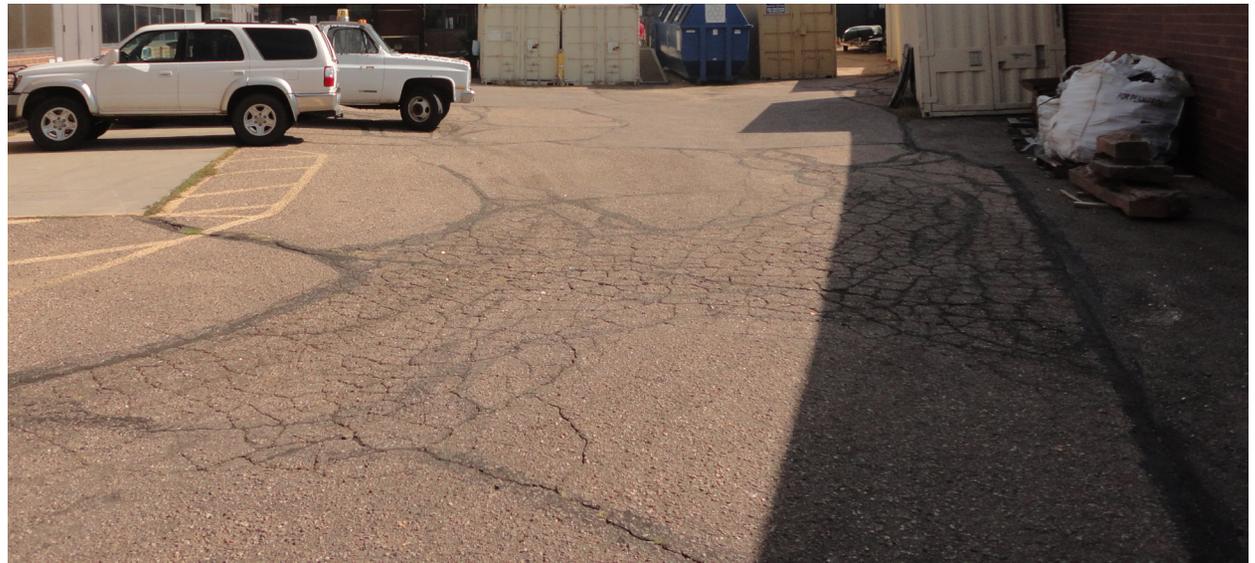
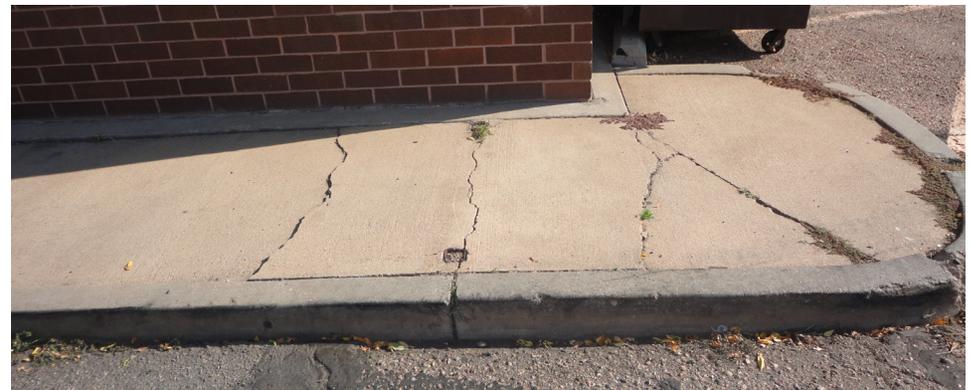
Paved Areas:

The concrete sidewalk and curb on the southwest corner of the building are badly cracked. The vehicle guardrail in this area is out of plumb. The asphalt paving in the service yard is in very bad condition, and in some areas has eroded away. The steel bollards in the service court are badly rusted. Cracks in the concrete slabs have developed at the corners of the area drains in the northeast porch and the sunken southeast area. Weeds and small trees are growing in the joints between the building grade beam and the adjacent paved areas in the service court and the equipment enclosure on the northwest side. The northeast porch is settling independently of the main building and a gap has opened up between the porch wall and the building.

Recommendations – Replace damaged sidewalk and curb. Repair vehicle guardrail. Repave asphalt areas in service yard. Strip and repaint bollards. Remove weeds/trees and seal joints. Seal crack between building and porch and monitor for additional settlement.

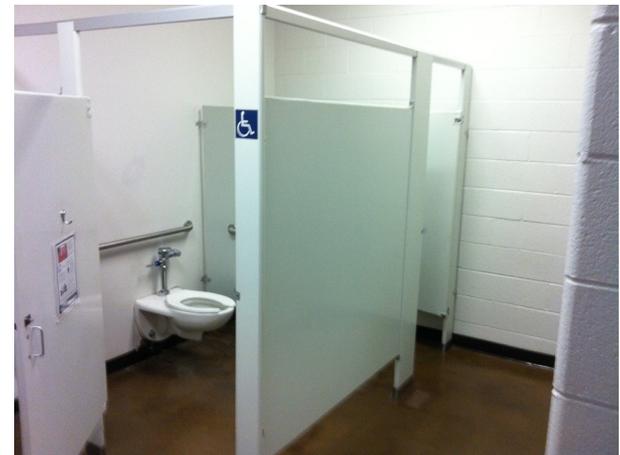
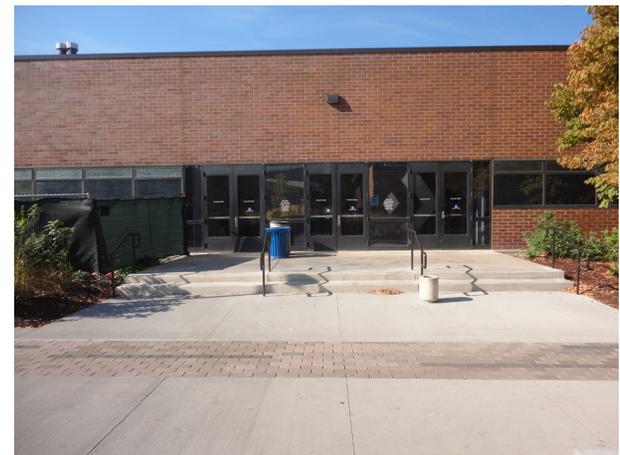
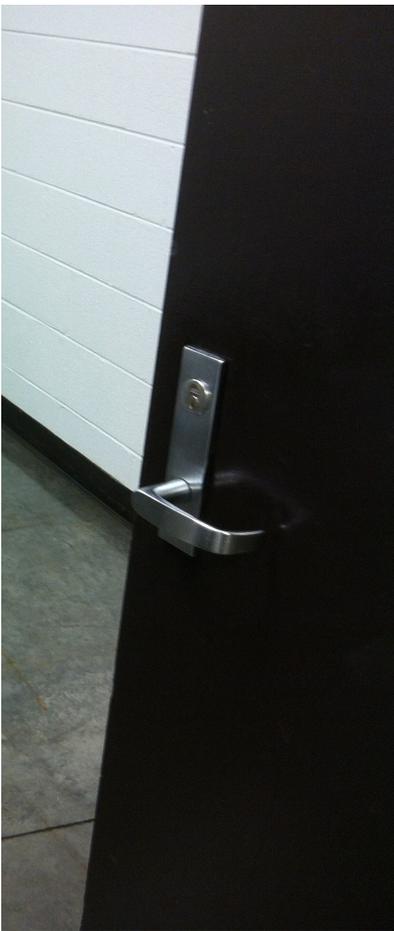
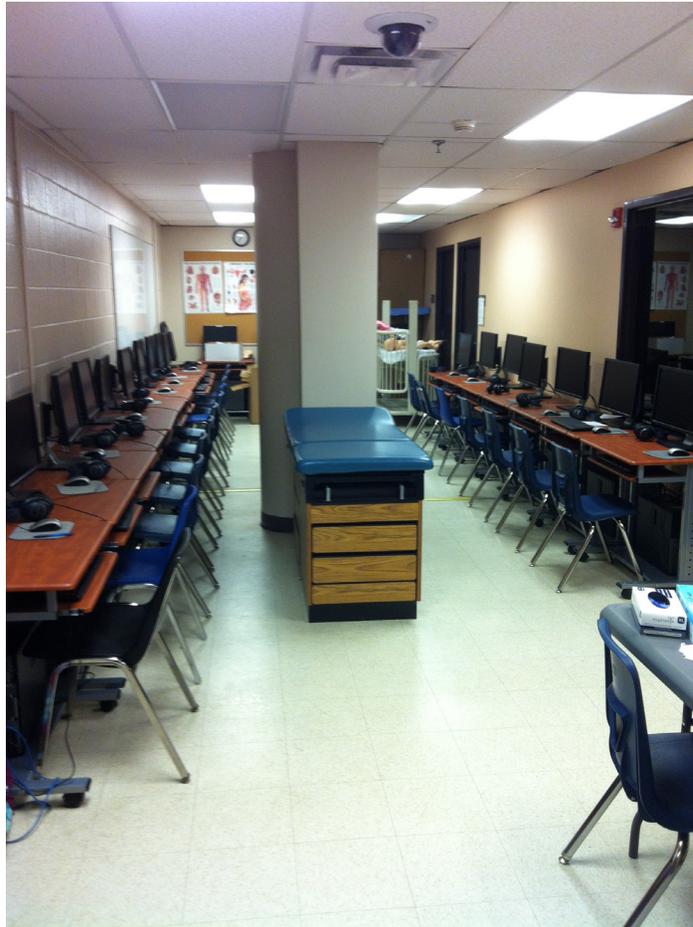
Code and Accessibility:

The Women's Restroom fixture count is approximately 50% short. The main building entrance on 10th Street has steps and is not accessible. No directional signage to one of the accessible entrances is present at this location. Interior signage lacks Braille text. Primary circulation corridors and passage doors appear to be ANSI 117-compliant. Many doors (mostly storage and service areas) do not have compliant lever handles. Many classrooms, workshops and labs have aisles that are too narrow for a wheelchair. Built-in casework, counters, sinks, lab benches and lab and shop equipment are not accessible. The main Men's and Women's Restrooms appear to be largely in compliance with ASNI 117, however restroom lavatories are too deep, missing insulated covers on drain pipes, and have non-compliant faucets. The small Women's Restroom R100A is not compliant, lacking accessible stalls, fixtures and clearances.

Recommendations – Expand Restroom R100A or construct an additional Women’s Restroom to add the required fixtures. Restroom R100C would be difficult to expand, as it is sandwiched between the main IT closet and the stair to the mechanical penthouse. Install new directional signage and ANSI 117-compliant interior signage. Replace doorknobs with levers. Rearrange furniture and equipment to provide accessible routes. Provide equivalent facilitation for built-in equipment. Replace sinks in accessible restrooms. Provide sign at R100A with directions to accessible restroom.

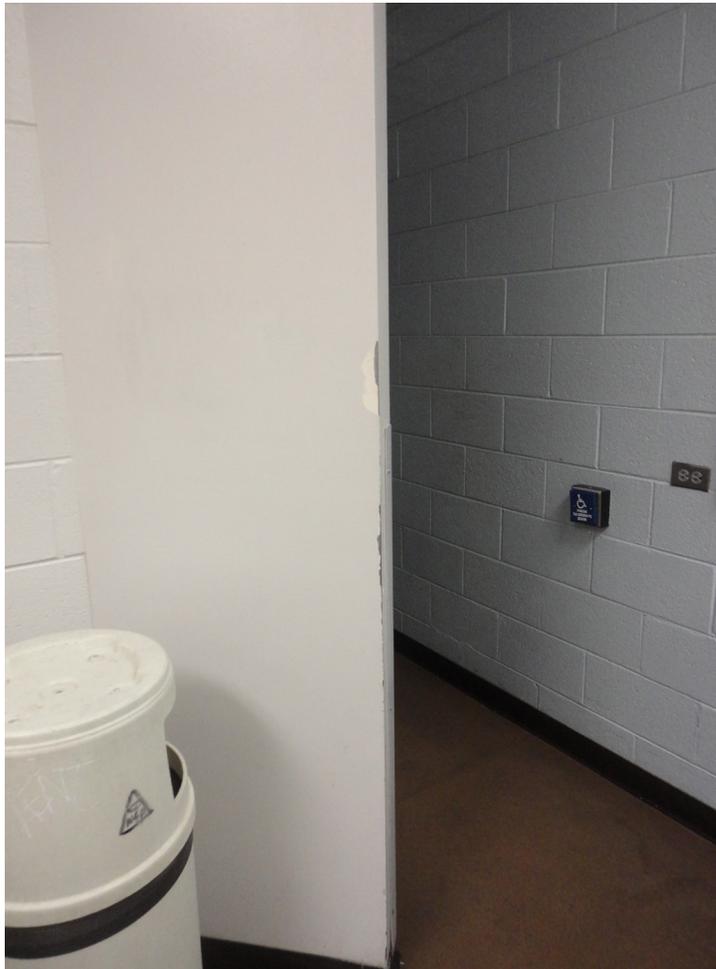
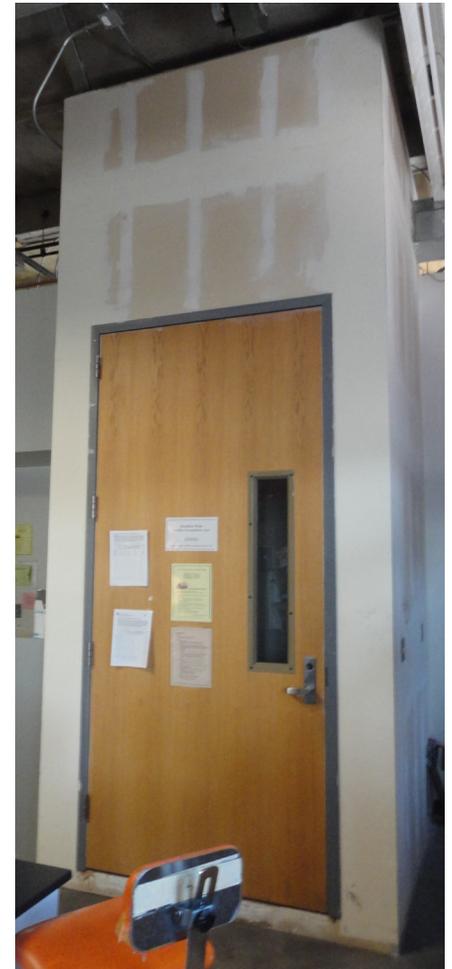
Drywall – There are few drywall partitions, and most are in good condition. A newly constructed storage area in the Civil Engineering Lab has unfinished drywall. The drywall furring at the exterior wall in the loading dock area has some small areas of damage. Where a new automatic door operator was installed at the northwest accessible entrance the drywall was left unfinished. The wingwall in the Men’s Restroom has damaged corners. The walls at the urinals are drywall, and should be finished with a moisture-resistant and washable surface.

Recommendations – Repair damaged drywall and finish unfinished drywall. Provide ceramic tile wainscot at urinals.

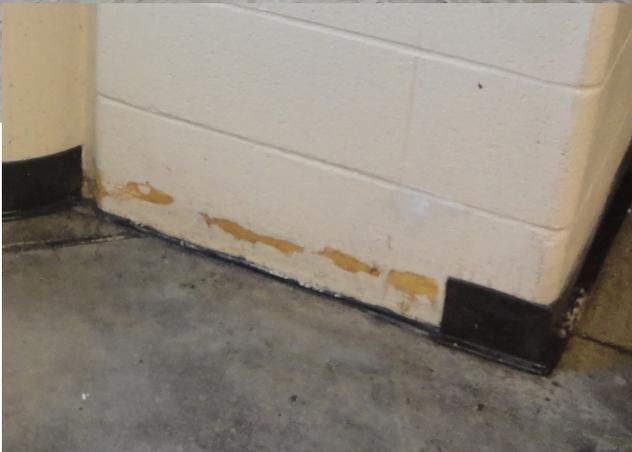
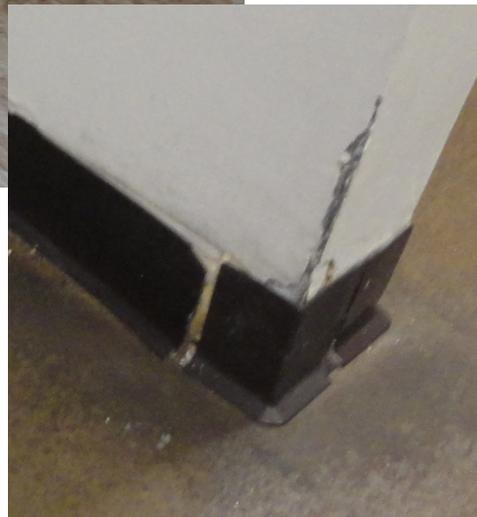
Wall Base – Sections of resilient base are loose or missing in several areas. Many rooms with CMU partitions and concrete floors have unnecessary resilient base.

Recommendations – Repair resilient base. Any new base should be installed in the longest practical sections to minimize seams.

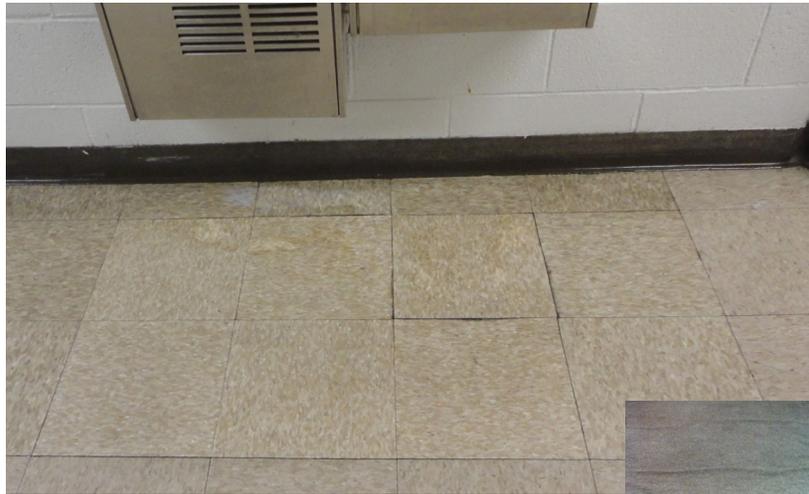
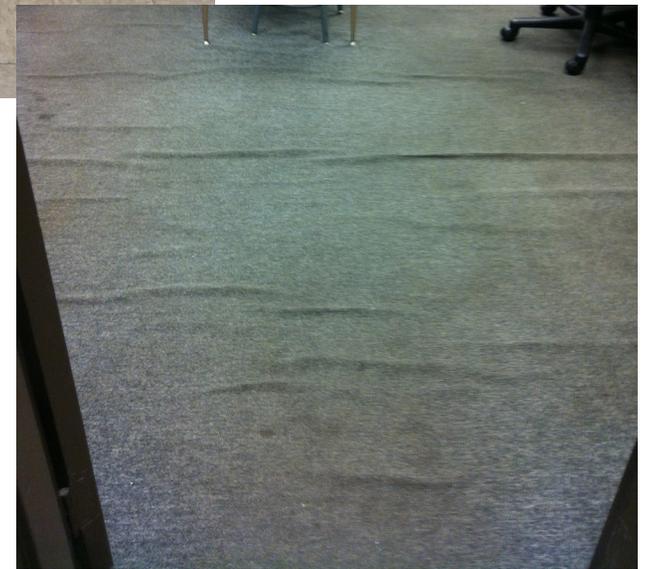
Flooring – Much of the resilient tile in primary circulation corridors is damaged. This tile and/or the mastic may be asbestos-containing. The tile at the drinking fountains in Corridor C100B is curling due to water damage. Several areas of tile have been replaced with new tile that doesn't match the existing. The broadloom carpet in the Industrial Design office area 124 and the Engineering Shops computer lab 119B are in poor condition. The carpet tile in the CCD computer center, classroom 104D and classroom 113 is fairly new and is in good condition. Most classrooms, studios, workshops and labs have sealed concrete floors. Most of these are in good condition, but limited areas are damaged or have been noticeably patched.

Recommendations – Test resilient tile and mastic for asbestos. Replace all original resilient tile with new. Replace broadloom carpet with carpet tile. Repair damaged concrete.

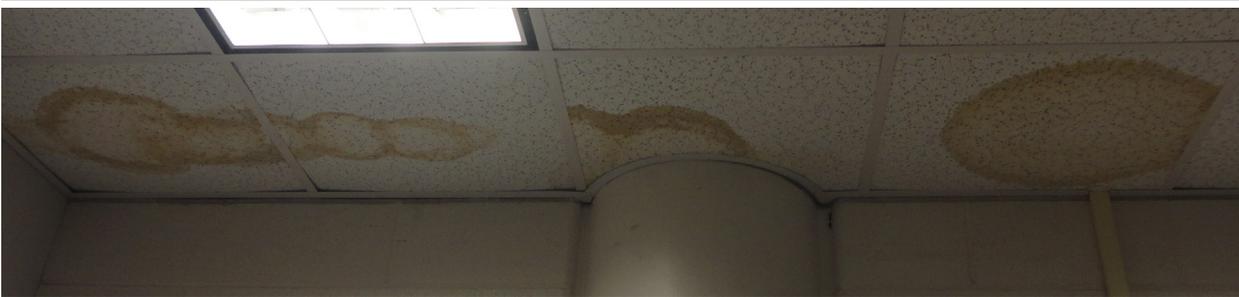
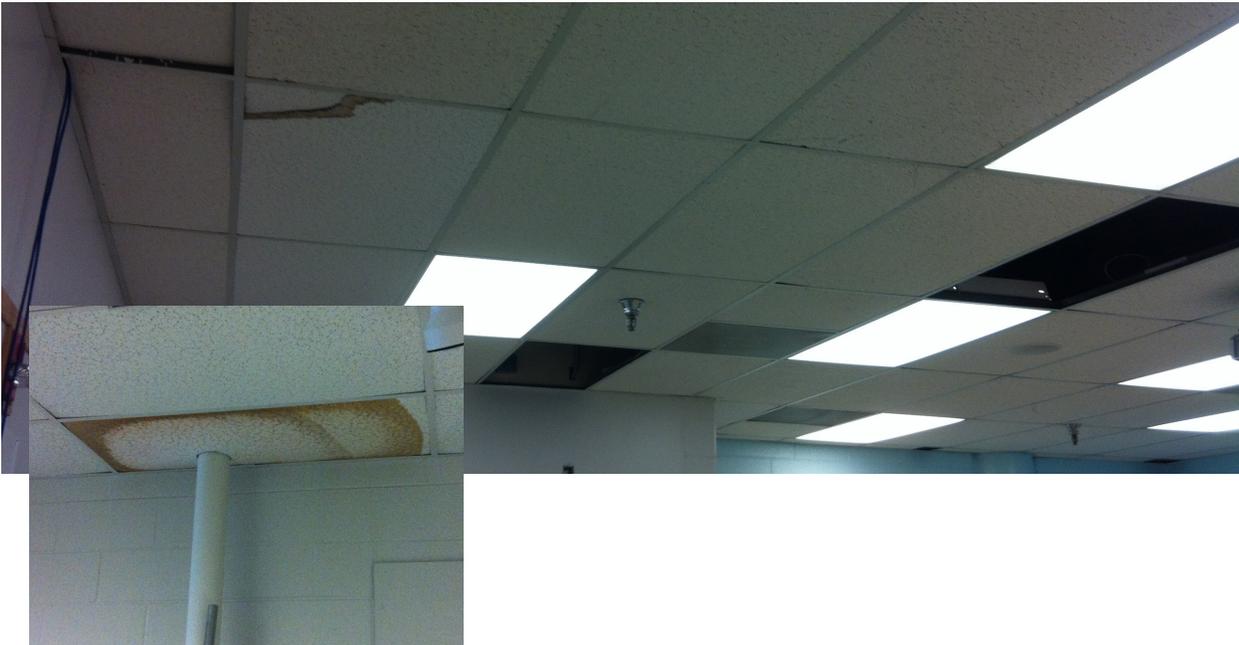
Ceiling Tile – With the exception of recently remodeled areas the acoustical ceiling tile is in poor condition with much water staining, and many tiles are missing. The suspended ceiling grid is in fairly good condition and will accommodate standard replacement ceiling tiles.

Recommendations – Replace all ACT, except at recently remodeled areas. Reuse existing ceiling grid.

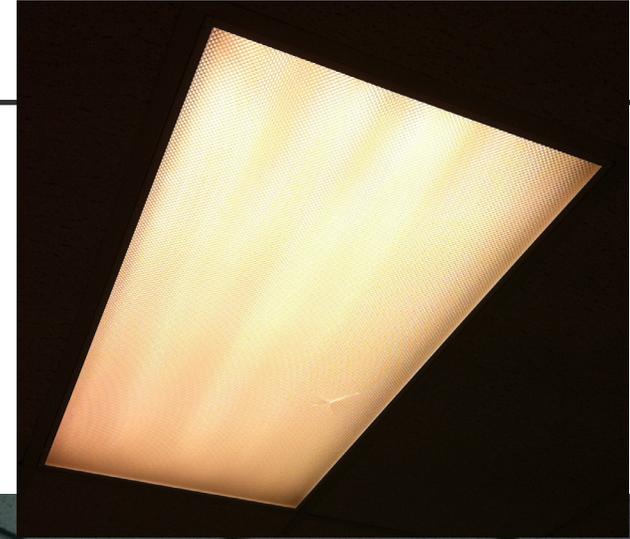
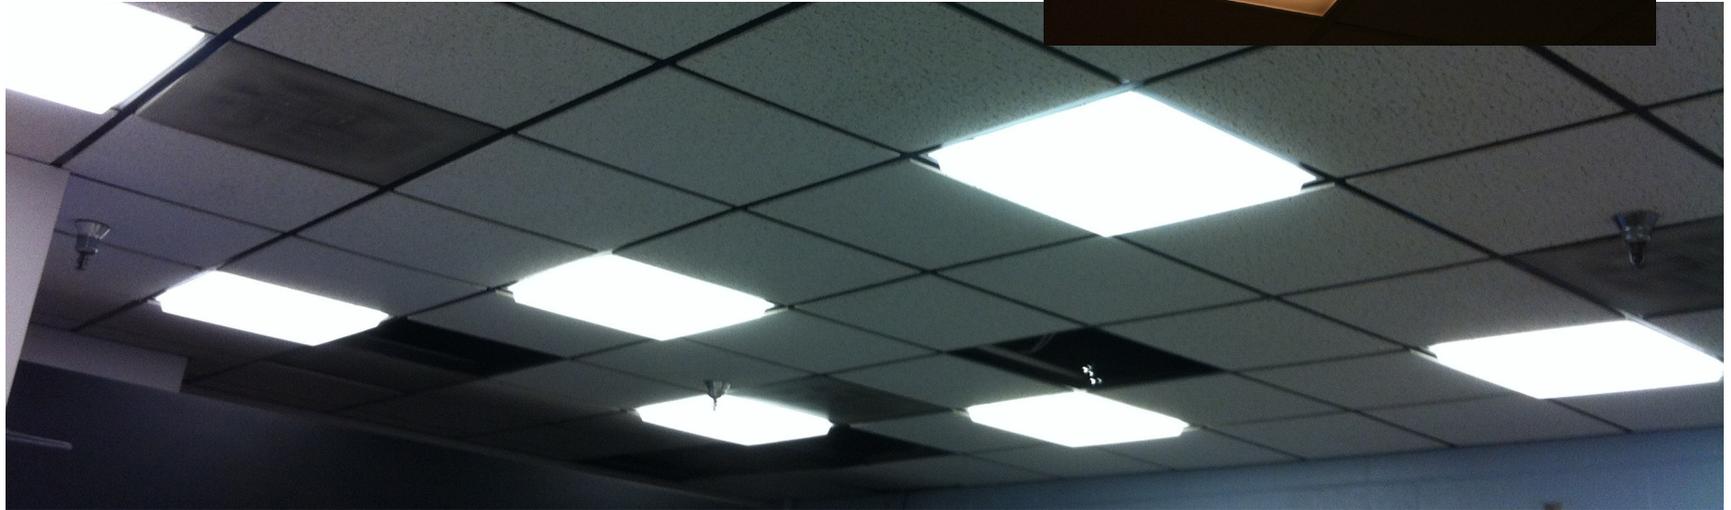
Lighting – Light fixtures vary widely. Most appear adequate, but several areas have outdated and inefficient fixtures, some with cracked or yellowed lenses.

Recommendations – Replace old and damaged light fixtures.

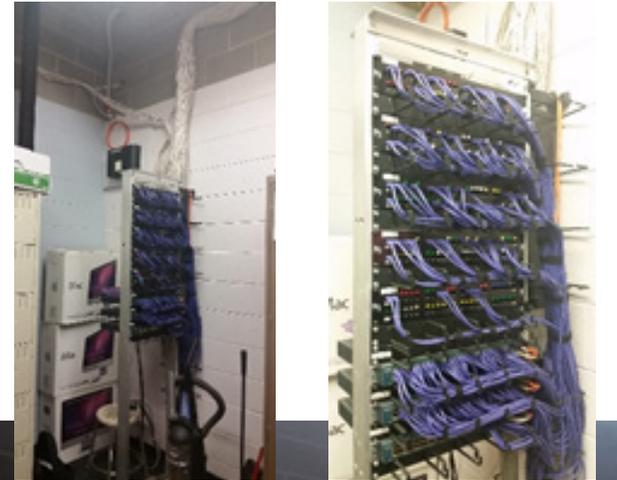
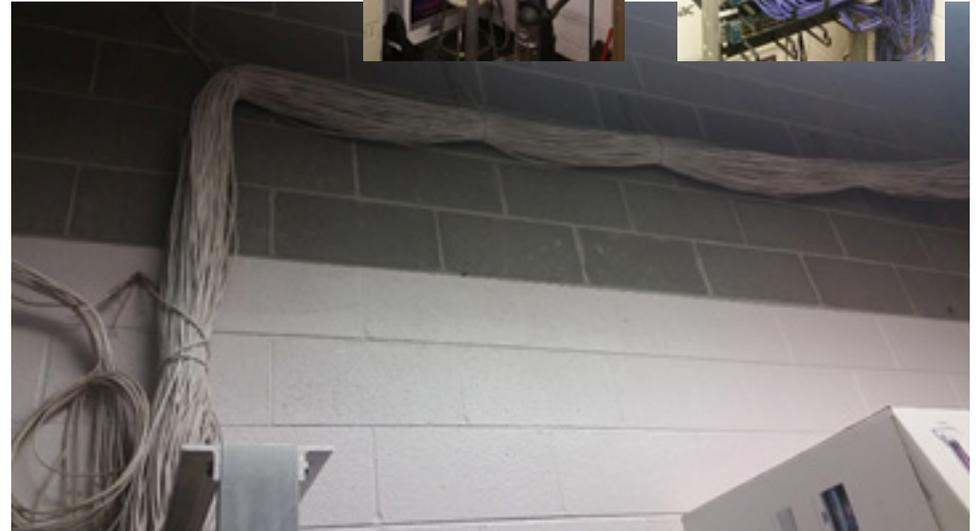
Computer Lab Equipment Room (ER):

104B. In addition to the TEF/MDF and TR/IDF there is another small network ER that serves the Computer Lab and two adjoining rooms. The room is also being used and occupied for other purposes. One wall has a small piece of plywood backer board, but does not appear to be fire-resistive treated. Fiber backbone cabling connects this ER to the TR/IDF. There is no phone field or punch-down blocks. The network switches are mounted in a two-post equipment rack. While there is one vertical cable manager attached to the equipment rack and the cables are bundled and dressed carefully, there is little or no structural cable management system in the rest of the room. The sleeves penetrating walls are completely full. A telecommunications grounding system was not observed. Power for the rack-mounted equipment comes from a surge suppressor power strip which is supported on a stool.

Recommendations – If the computer lab remains we recommend the equipment be moved to the TR/IDF room since the cabling distance would not exceed 90 meters and there is sufficient space to add another rack in the TR/IDF or add equipment to the existing rack there now. However this will require re-cabling all of the workstations. See “Cabling” paragraph below for further discussion.

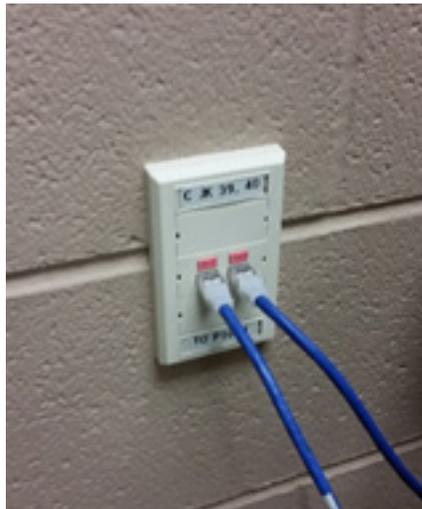
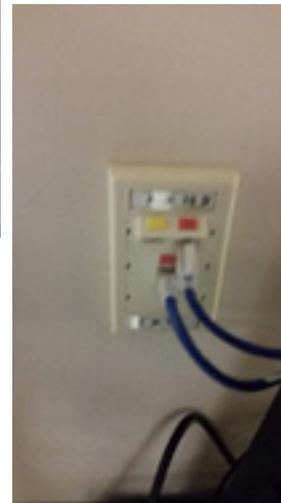
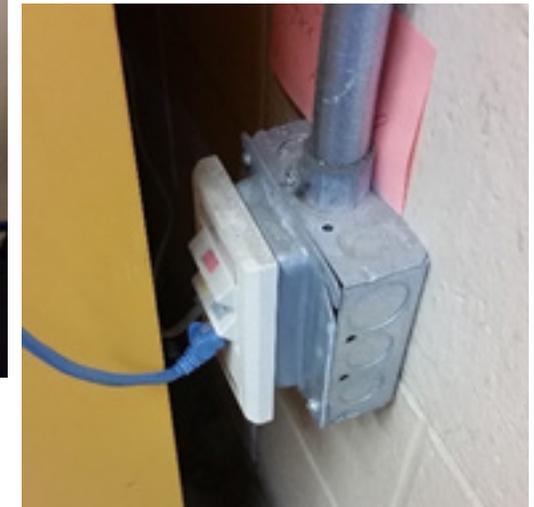
Cabling -

The backbone fiber cabling appears to be in good condition. The existing horizontal station cabling appears to be Category 5e. Existing data outlets have a mix of faceplate styles and terminations, some angled and others flush, some recessed and others are surface mounted.

Recommendations – Replace all of the Category 5e cable with Category 6 to take advantage of higher throughput. Select one style of faceplate and replace those that do not match that style.

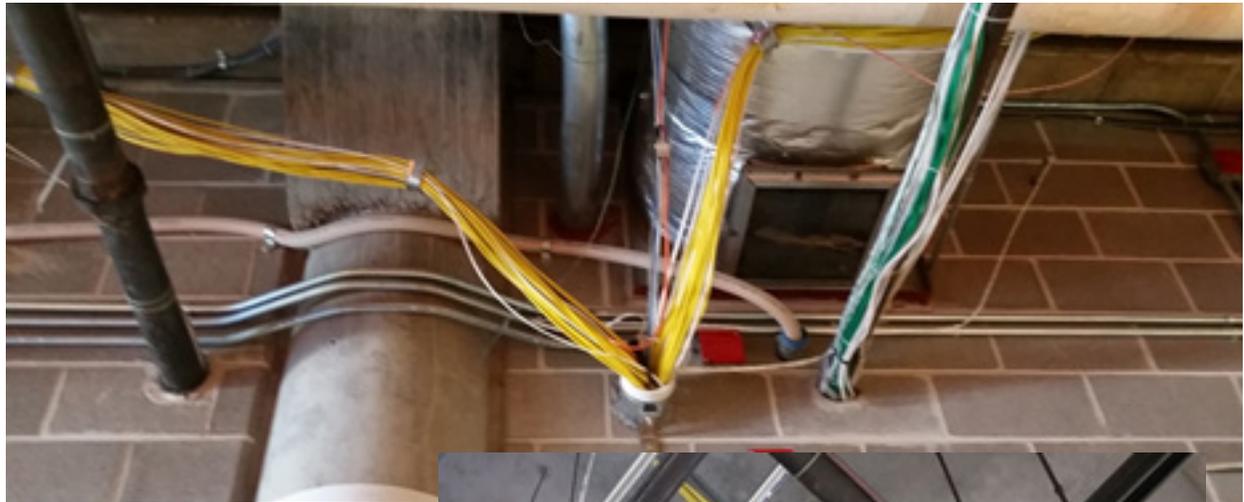
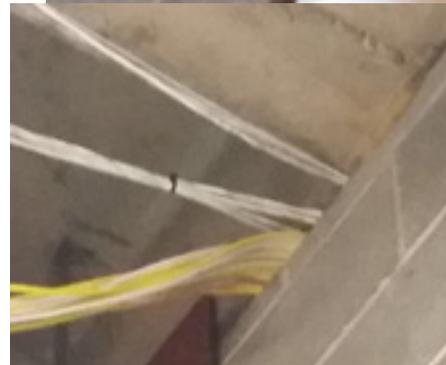
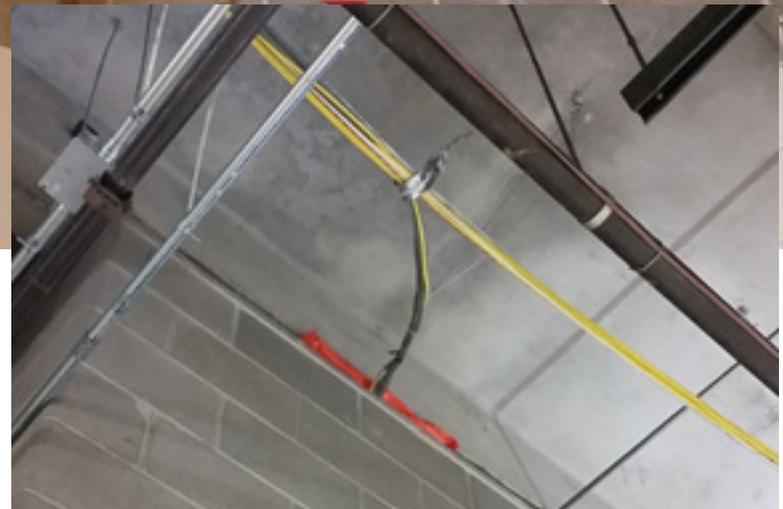
Cable Pathway and Supports -

Currently fiber cabling is contained in innerduct which runs overhead down some of the corridors attached to the wall, while bundles of copper cabling is suspended in many places by J-hooks. Some cabling passes from the corridor into the adjoining spaces through gaps at the tops of CMU walls, while other cabling passes through sleeves that are completely full.

Recommendations – Provide cable tray suspended overhead down all of the corridors wide enough to properly support all the fiber and copper communications cabling. Add additional conduit sleeves to enable cabling to penetrate walls where necessary to relieve already congested sleeves; consider use of such devices like EZ-Path where smoke and fire protection may be required.

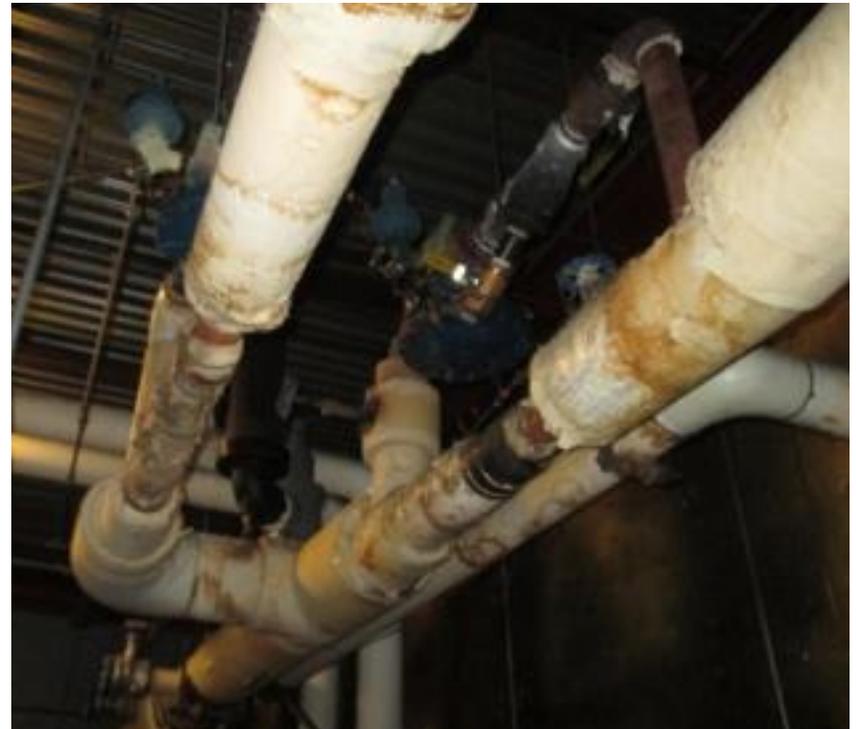
Figure III-1. Main steam to heating water shell and tube heat exchangers.

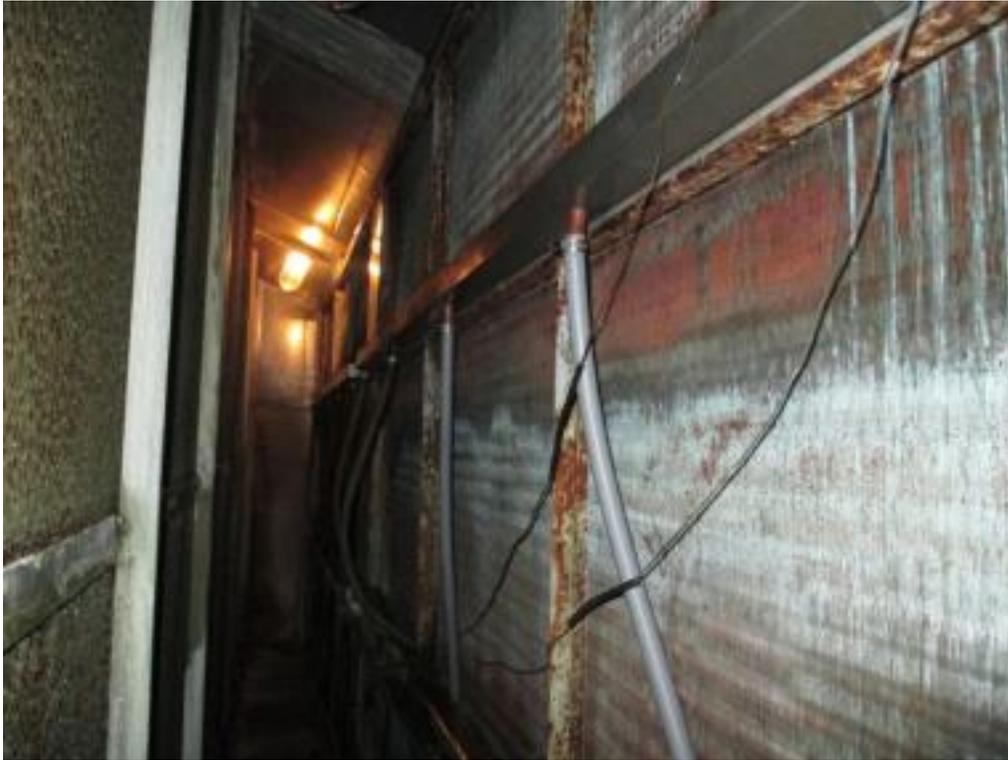
Figure III-4. AHU-1 direct evaporative cooler and main chilled water cooling coil.

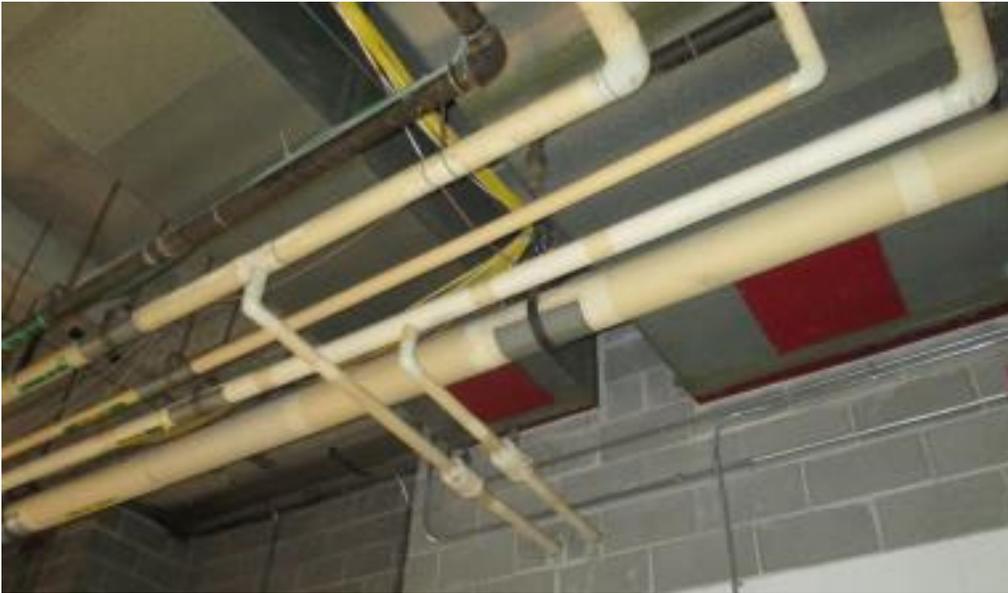
Figure IV-1. Existing domestic water piping. Cold water, hot water, hot water recirculation, compressed air, building heating water, and fire protection piping shown. Note the domestic water shut off valves for the branch piping.
