Boulder Creek Building Program Plan

COMMUNITY COLLEGE OF DENVER

16 JUNE 2016

Detailed Conditions Assessment - Exterior

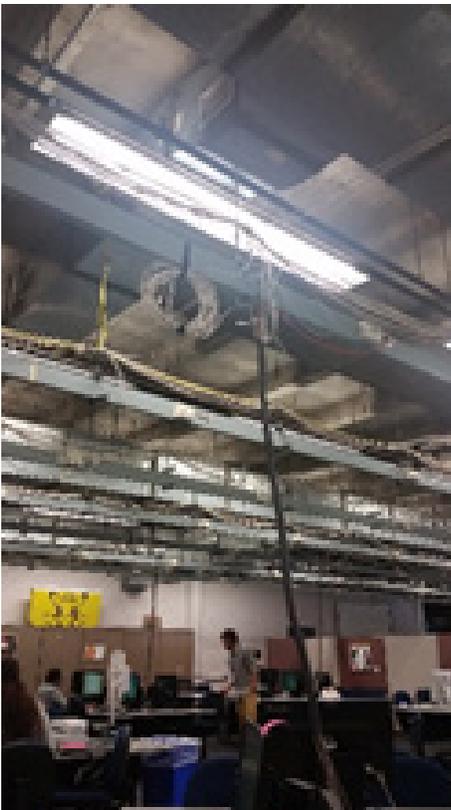
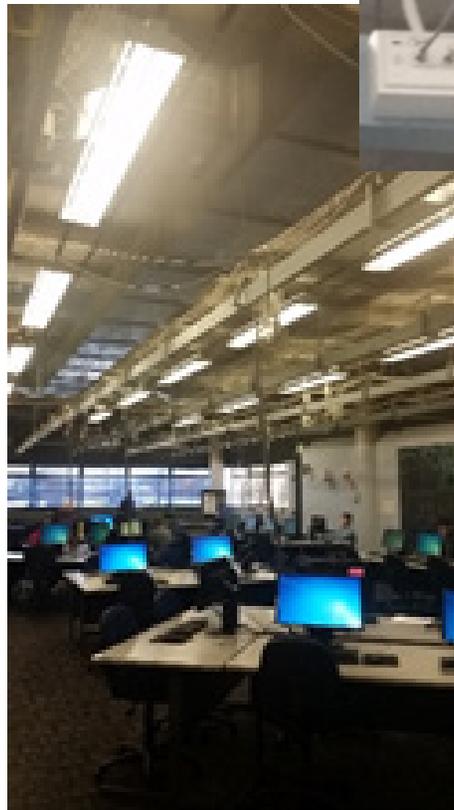
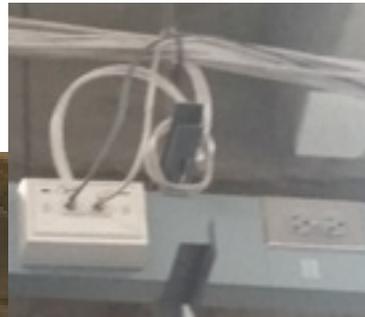
Computer Lab:

104. There is a large matrix of overhead raceway distributing power and some data to each workstation. However, there is a multitude of computer cabling attached to the outside of the raceway that is not properly supported and dangles down to the individual workstations.

Recommendations – If the computer lab remains, we recommend that as a minimum overhead cable tray be install next to the raceway to properly support the cabling. In addition, combination power-and-data poles should be provided down to each workstation. However, an alternate solution is to sawcut the floor and install underground conduit to floor feeds to the furniture. This would need to be coordinated with electrical for the same type of distribution from the floor rather than overhead. There are also some very low profile (as low as 2-1/2 inches) raised floors that can also be used.

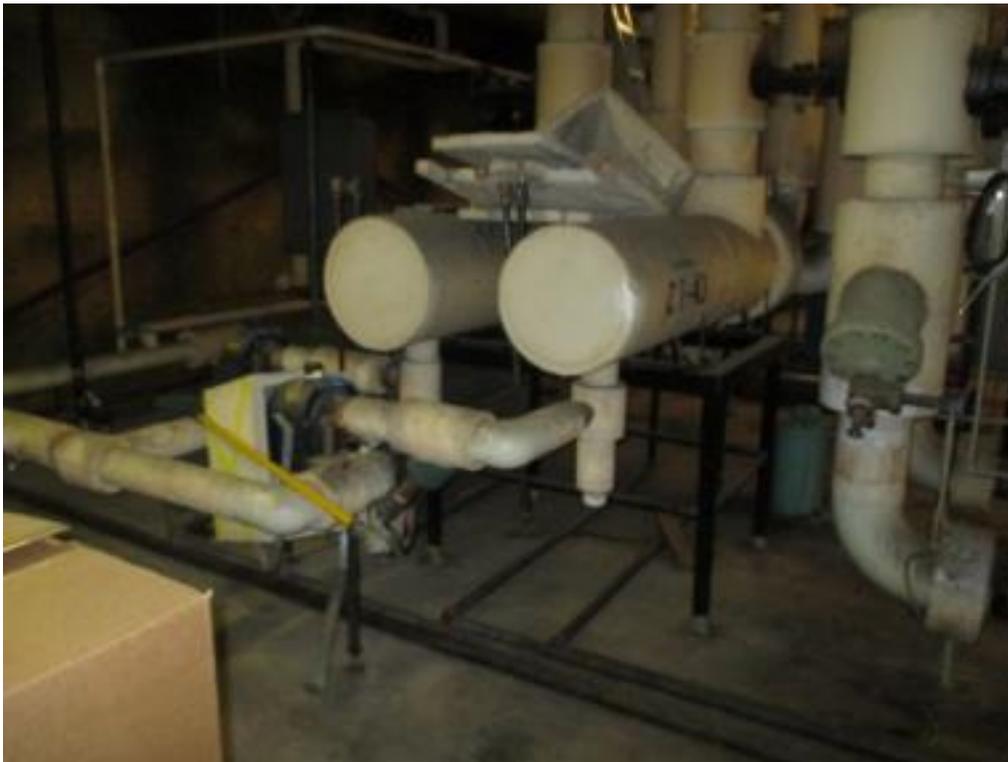
Figure III-2. Main steam to heating water shell and tube heat exchangers.

1. *All hydronic and steam piping, original to the building, is in poor condition and is beyond its expected service life and was observed with degraded piping insulation. Due to the age of the piping, it is recommended that the entire heating hydronic piping be replaced to reduce number of leaks and reduce pumping energy brought on by mineral build up inside pipe. Insulation should also be replaced to meet current energy codes.*
2. *The main hydronic heating water pumps are in poor condition and should be replaced since they are beyond their expected service life. The hydronic heating water pumping strategy should be changed to incorporate a variable flow pumping system to increase potential energy savings.*

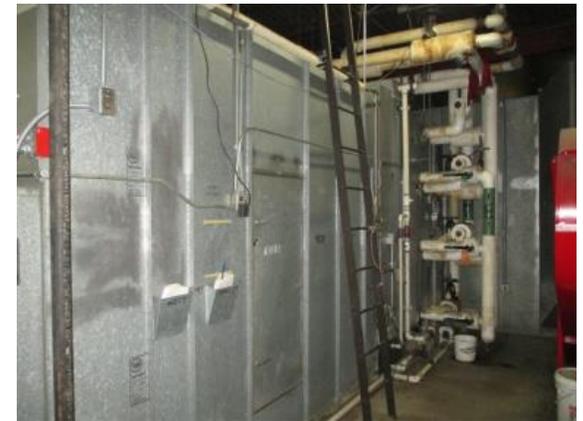
Figure III-5. Existing AHU-1 custom field built-up air handling unit

1. All air handling equipment and components are in poor condition and are beyond their estimated service life. Equipment should be replaced and sized

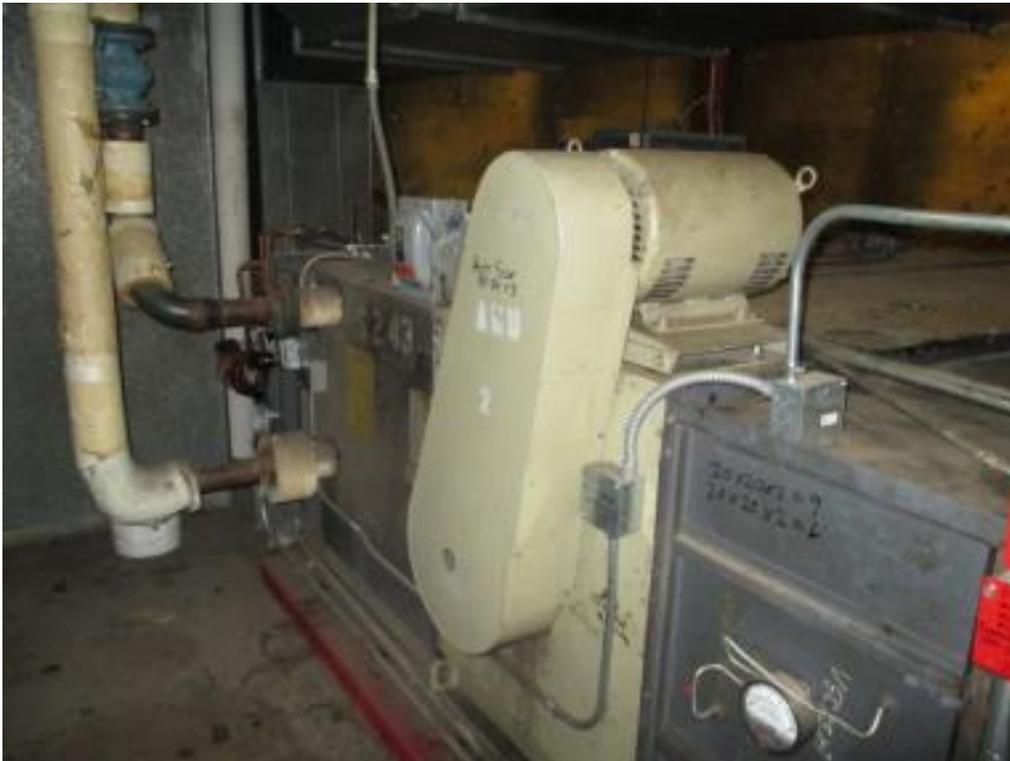
Figure III-7. Existing AHU-2 modular, multi-zone air handling unit.

2. AHU-2: This unit is a multi-zone, constant air volume, heating only, modular type air handling unit. Based on the existing BC plans, the air handling unit is designed to deliver approximately 16,730 CFM. The outside air is filtered and ducted through an intake louver at the southwest penthouse wall. A pumped heating water coil provides tempered air to three (3) zone supply ducts. The modular type air handling unit appears to be original to the 1974 building.

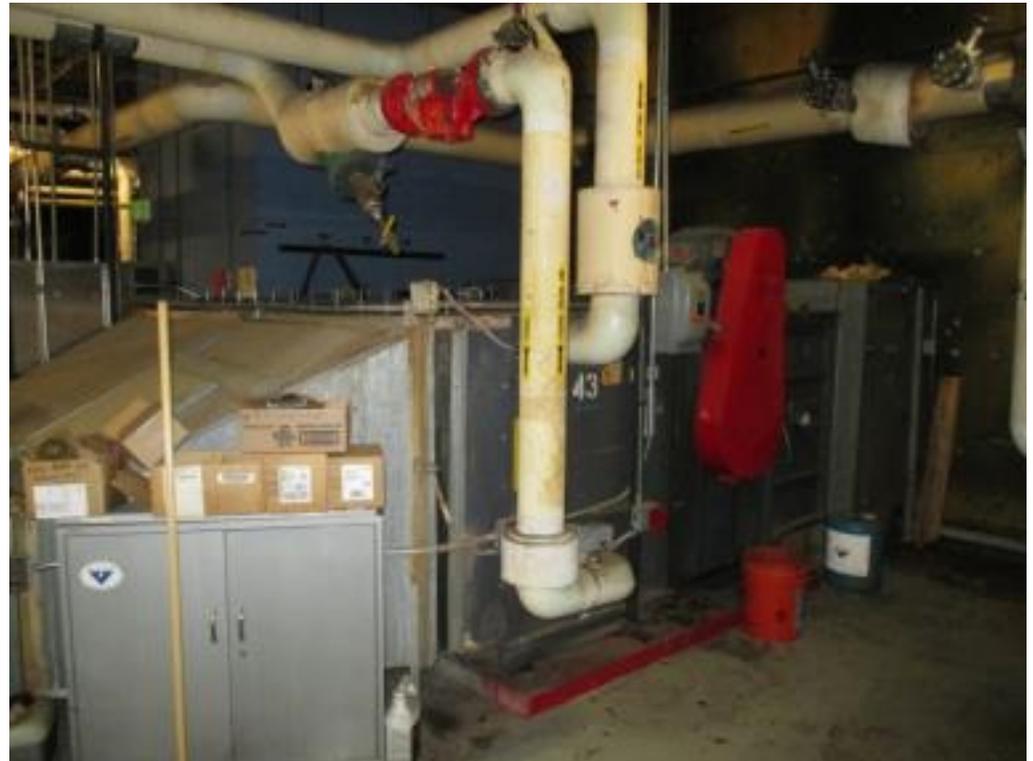
Figure III-8. Existing AHU-3 multi-zone 100% outside air handling unit.

3. AHU-3: This unit is a multi-zone, constant air volume, heating only, 100% outside air, modular type air handling unit. Based on the existing BC plans, the air handling unit is designed to deliver approximately 17,565 CFM. The outside air is filtered and ducted through an intake louver at the northwest penthouse wall. A pumped heating water coil provides tempered air to distributed ductwork serving rooms 121. The modular type air handling unit appears to be original to the 1974 building.

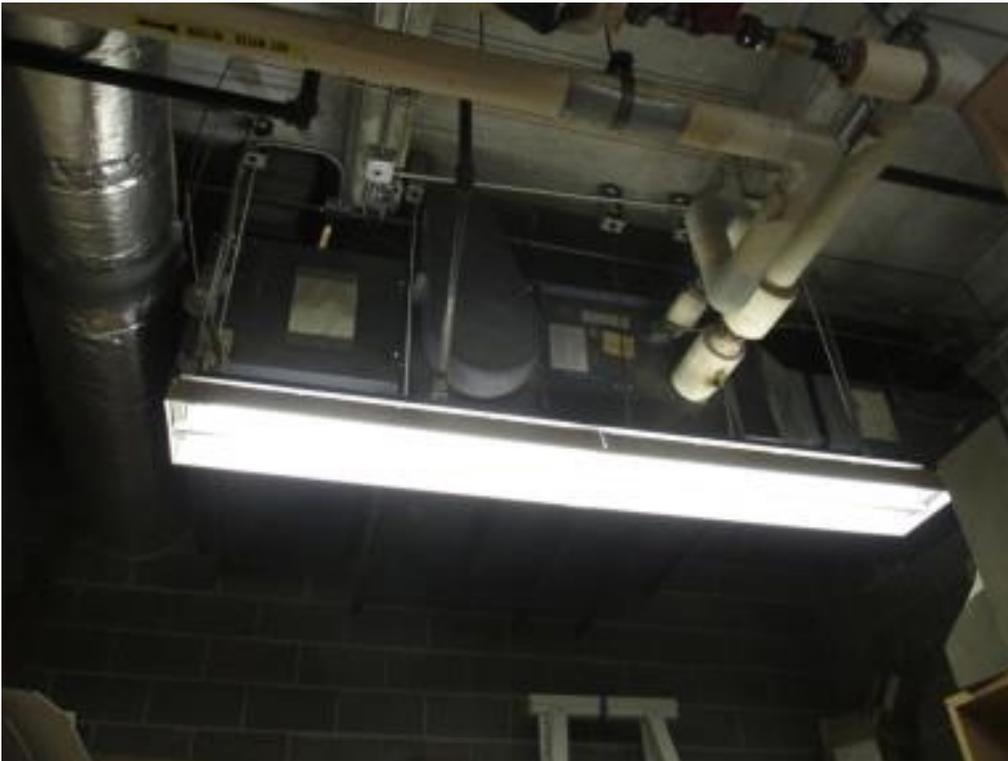
Figure III-9. Existing AHU-5 suspended from structure with pump heating water coil.

5. AHU-5: This unit is a suspended, constant air volume, heating only, 100% outside air handling unit. Based on the existing BC plans, the air handling unit is designed to deliver approximately 2,800 CFM. The outside air is filtered and ducted through the roof to a roof intake hood. A pumped heating water coil provides tempered air to distributed ductwork serving Paint Spray Booth room 132A. The suspended air handling unit appears to be original to the 1974 building.

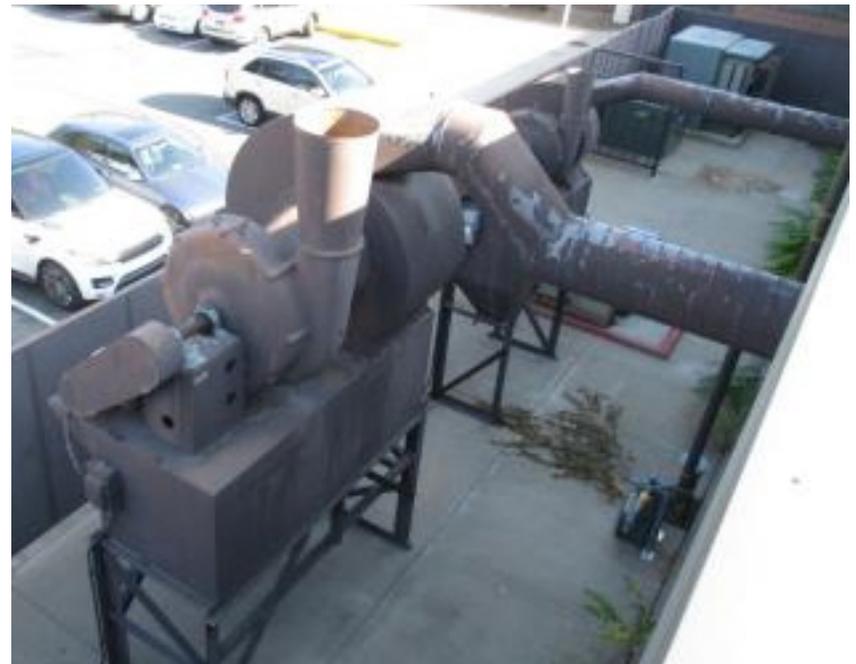
Figure III-10. Existing wood shop dust collector EF-9-43 & existing dust collection EF-8-43 (beyond)

4. EF-9-43: Woodshop dust collector exhaust fan is located on north side of the BC building within the screened utility enclosure. The dust collection system is connected to several pieces of woodworking equipment located in the Woodshop - 132 and served by a 20”Ø exhaust main duct. The dust collector is original to the 1974 building construction and does not meet current codes and/or NFPA requirements for dust collectors.

1. All exhaust equipment is in poor condition and is beyond their estimated service life. Equipment should be replaced and sized to meet current mechanical and energy codes and ventilation air requirements to maintain acceptable indoor air quality (IAQ).
2. The existing dust collection systems are not in compliance with current

mechanical or NFPA requirements for dust collectors and explosion controls. Both dust collector systems are in poor condition and are beyond their estimated service life.

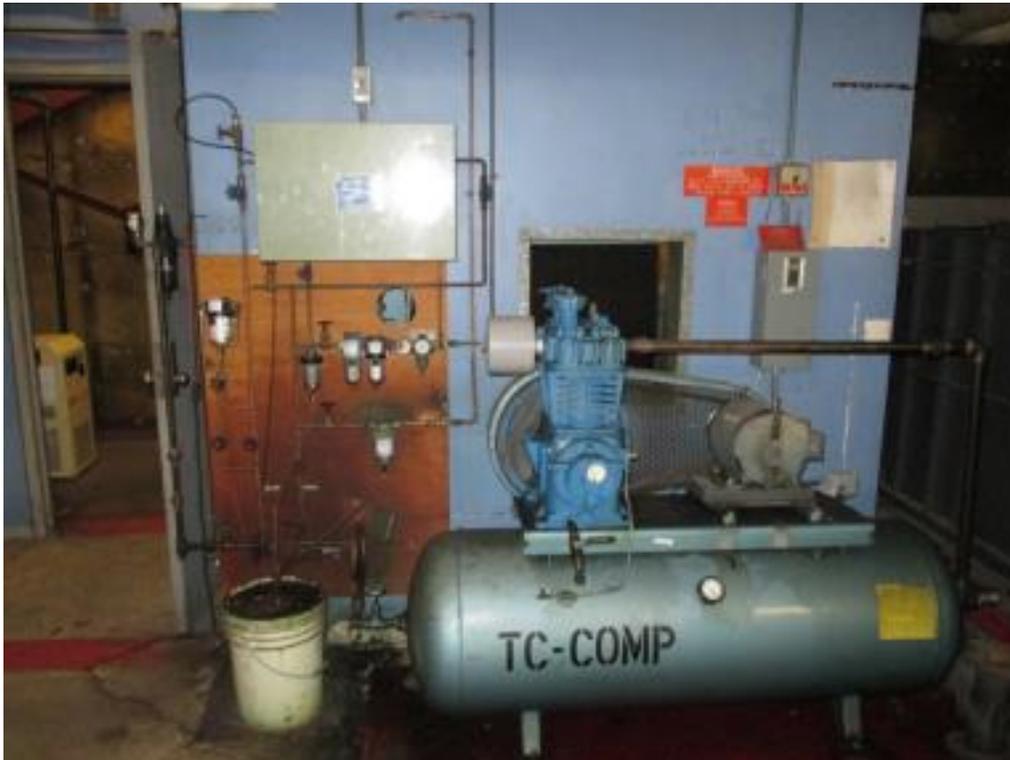
Figure III-11. Existing pneumatic temperature control air compressor.

1. The building's temperature control system is a hybrid of predominantly pneumatic controls and localized direct digital controls (DDC) for some of the smaller remodel work.
2. The pneumatic temperature control compressor is located in the mechanical penthouse. The air tank appears to be original but the compressor and motor appear to have been replaced.
3. The pneumatic control air serves the following components throughout the building: control dampers, thermostats, control valves, pneumatically adjustable inlet vanes fans, etc.

The pneumatic control system is in poor condition and is limited in its capabilities by current sequence of operations required to meet energy codes and reduce overall energy consumption with air and hydronic systems. The entire building's pneumatic temperature control system should be replaced with DDC controls and revised sequence of operations should be provided for all equipment.

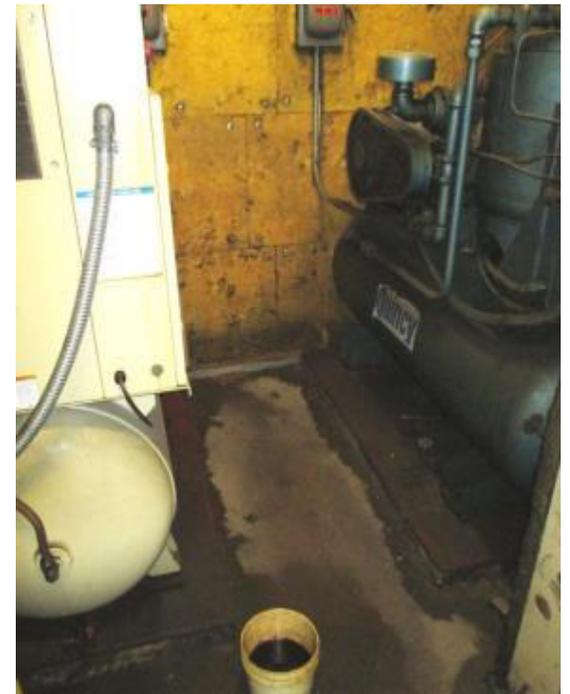
Figure IV-4. Existing compressed air plant.

The compressed air piping mains and isolation valves appear to be original to the building and are in poor condition. The existing compressed air plant is in fair to poor condition and is beyond its expected service life with exception to the newer air compressor and refrigerated air dryer. It is recommended to replace the Quincy air compressor and continue with regular maintenance of the remaining Ingersoll

Rand equipment. Additionally, all plant and point of use compressed air filters should be replaced with new throughout the building.

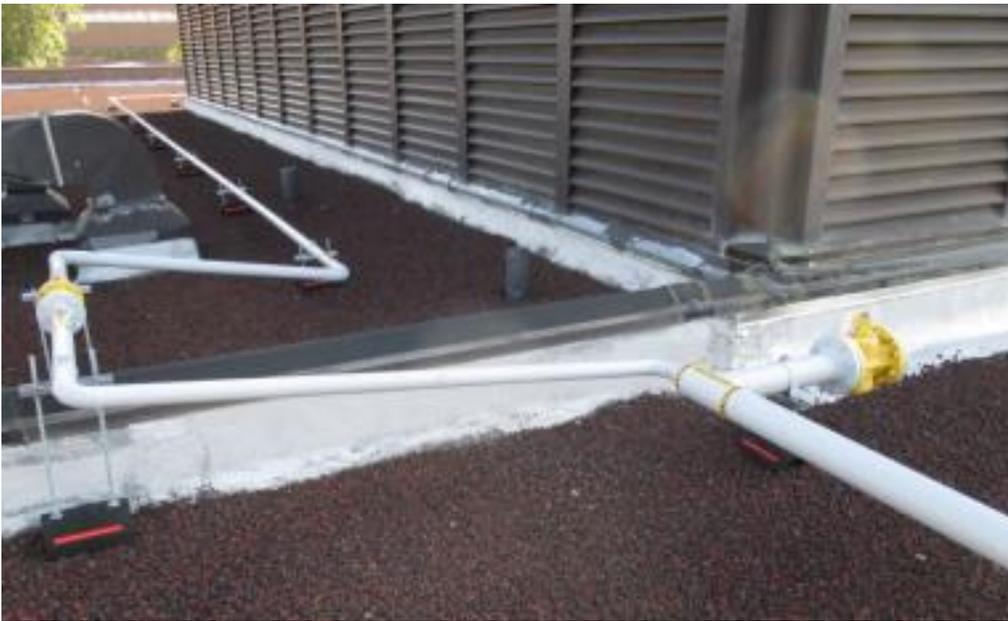
Figure V-5. Existing natural gas piping routed on roof.

There are no recommendations for the existing natural gas service or distribution. Existing system appears to be adequate size and good condition.

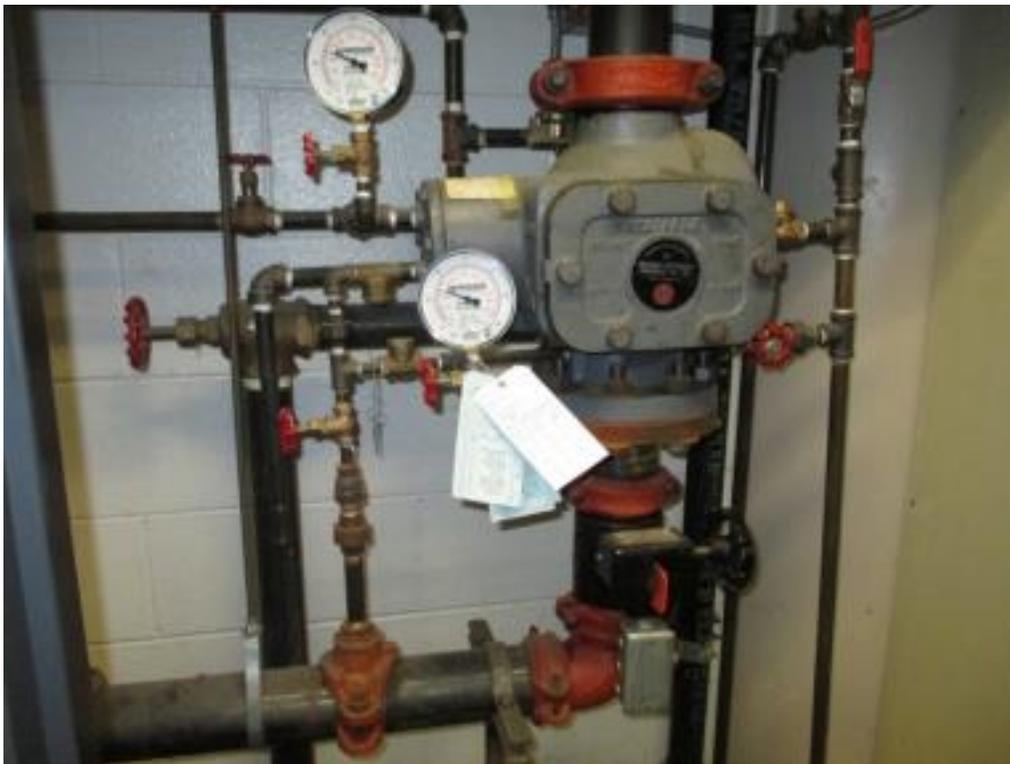
Figure V-1. Existing single interlock, pre-action fire suppression system in Room 104.

Room 104 is currently being served with a pre-action type fire sprinkler system for the computer lab and appears to be in good to fair condition and adequately sized for the current space served. There are no recommendations to this dedicated fire protection system.

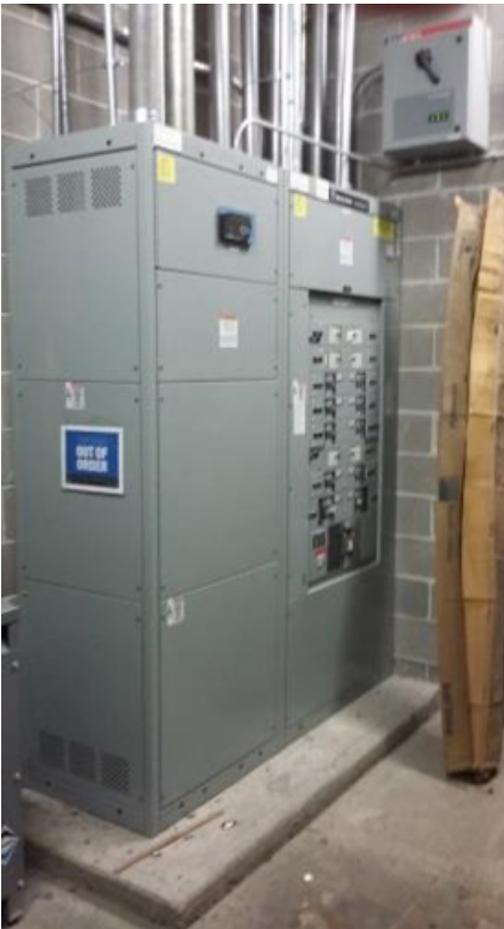
Figure VI-1. Switchboard “MDC”.

1. The existing Main Switchboard MDC is in good condition. Based on information published in 2008, the peak demand on the electrical service is 539 Amps. However, MDC has no available spare or spaces to accommodate the addition of downstream distribution equipment to serve additional loads. Depending on the scope of recommended renovation and HVAC system upgrades, significant modifications to or replacement of the existing MDC may be required.
